4. TITLE (and Subtitle) Stodge Meadow Pond Dam NATIONAL PROGRAM FOR INSPECTION OF NON-FEDERAL DAMS		5. TYPE OF REPORT & PERIOD COVERED INSPECTION REPORT

STODGE MEADOW POND DAM

MA 00009

FEBRUARY 1979

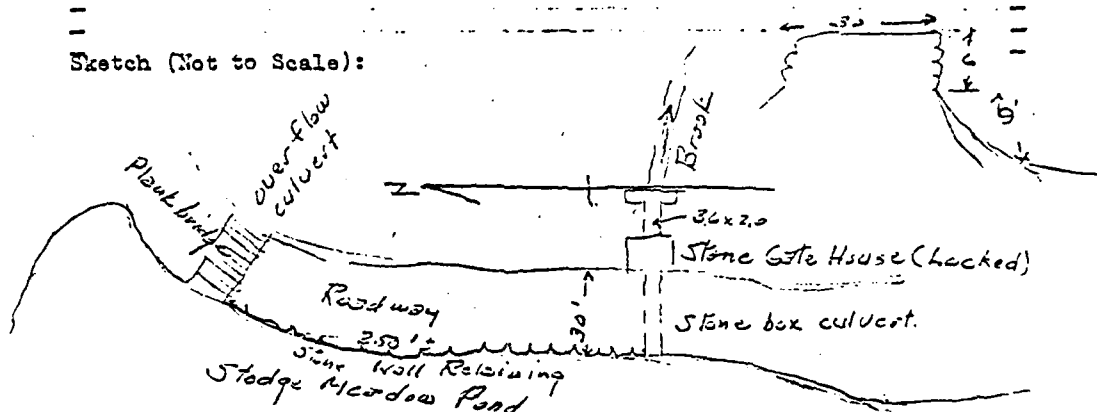
Sketch (Not to Scale):

Stone-walled earth filled dam

Trees up to 8" growing on sides of road across dam. Should be cut.
